Above the Flood: ELEVATING YOUR FLOODPRONE HOUSE

FEDERAL EMERGENCY MANAGEMENT AGENCY

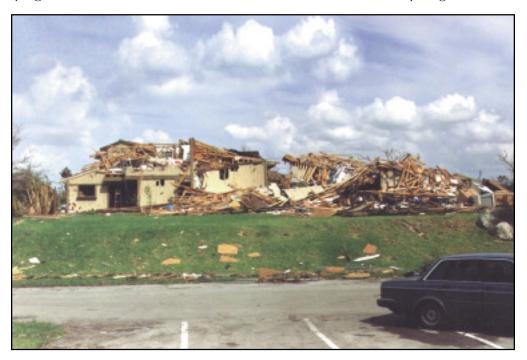
Figure 3 Wind damage.

The widespread destruction caused by Andrew was due primarily to high winds (Figure 3). However, flood waters contributed to the damage in low-lying coastal areas of central and southern Miami-Dade County (Figure 4).

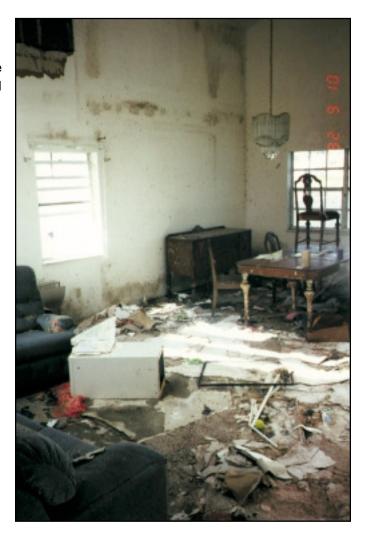
Figure 4
In low-lying areas,
wind and rain damage
to interior finishes and
furnishings was
exacerbated by flood
waters.

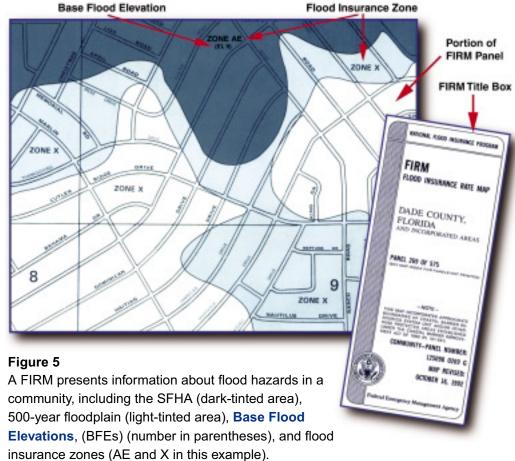
Communities participate in the NFIP by enacting and enforcing floodplain management regulations to reduce future flood risks. At a minimum, these regulations govern construction in the **Special Flood Hazard Areas (SFHAs)** shown on Flood Insurance Rate Maps (FIRMs) issued by FEMA (Figure 5).

Note that the SFHA in the example in Figure 5 is designated Zone AE. This zone is only one of several applied to SFHAs under the NFIP, including V, VE, V1-V30, A, AE, A1-A30, AO, and AH. These zones indicate differences in the types and severity of flood hazards in SFHAs. For the purposes of this publication, it is sufficient to focus on the basic differences between the two main types of SFHA zones—V zones and A zones. The distinction is important because regulatory requirements associated with V zones and A zones differ significantly. As explained later in this chapter, these requirements affect the types of building elevation techniques that may be used under the NFIP.

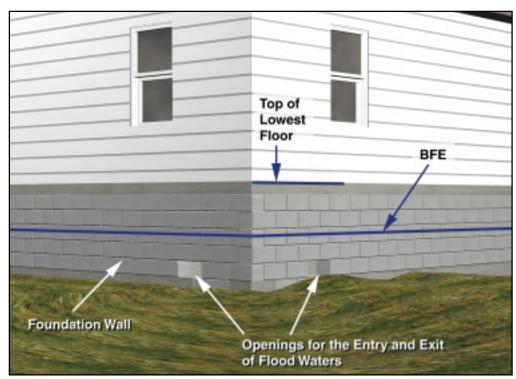
Figure 6In a new, substantially improved, or substantially damaged building in an A zone, the elevation of the lowest floor must be at or above the BFE.

In A zones, where flood hazards are less severe, buildings may be elevated either on an open foundation or on continuous foundation walls below the BFE (Figure 6). Regardless of the type of foundation used, A-zone buildings must be elevated so that the **lowest floor** is at or above the BFE, as shown in Figure 6. If continuous walls are used below the BFE, they must be equipped with openings that allow flood waters to flow into and out of the area enclosed by the walls (Figure 6). Allowing the entry and exit of flood waters ensures that water pressures will be the same on both sides of the walls and reduces the likelihood that water pressure will cause the walls to fail.

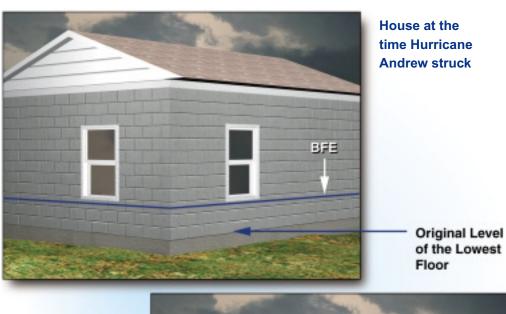
Figure 7
Technique 1 –
Extend the walls of the house upward and raise the lowest floor.

- 1. Extend the walls of the house upward and raise the lowest floor (Figure 7).
- 2. Convert the existing lower area of the house to non-habitable space and build a new second story for living space (Figure 8).
- 3. Lift the entire house, with the floor slab attached, and build a new foundation to elevate the house (Figure 9).

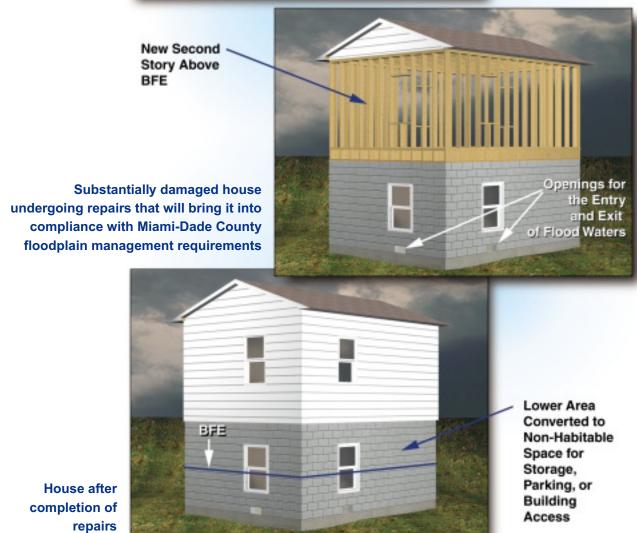
Figure 9 Technique 3 – Lift the entire house, with the floor slab attached, and build a new foundation to elevate the house.

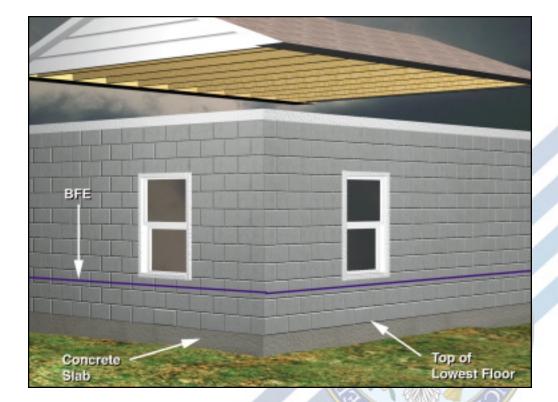
Figure 10
The first step in
Technique 1 is
removing the roof.

Technique 1 is appropriate for houses with concrete or masonry walls, but not for houses with other types of walls, such as those framed with wood studs, which would be more vulnerable to flood damage. This technique is usually appropriate when the depth of the base flood at the house is no more than 4 or 5 feet above grade. The elevation process begins with the temporary removal of the roof and roof framing, in a single piece if possible (Figure 10). This is commonly done with a crane. The roof is then stored on site so that it can be reinstalled later. The next step is to remove the windows and doors.

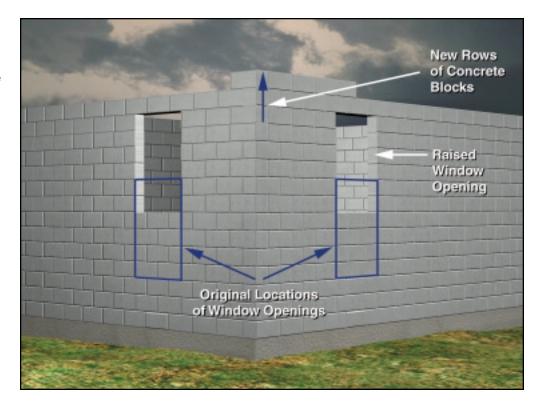
Figure 11
The tops of the walls and bottoms of the window openings are raised with concrete blocks.

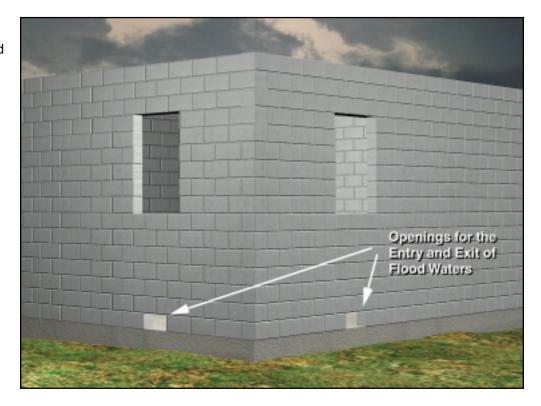
Figure 12
Openings are created in the walls near the ground.

Blocks are removed from the walls of the house at selected locations within 1 foot of the ground (Figure 12). The resulting openings will allow flood waters to flow into and out of the lower area of the house so that the water pressures on both sides of the walls will remain the same. The roof and windows are then replaced, and a new wood-frame floor is constructed above the flood level (Figure 13).

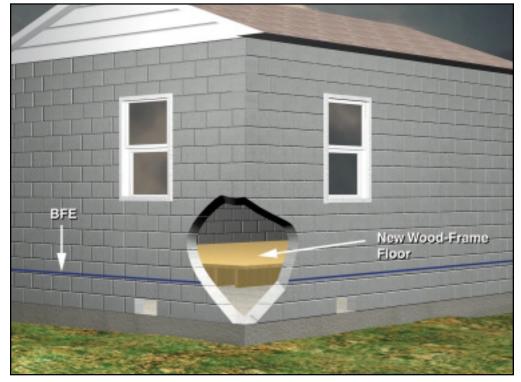
Figure 13
A new wood-frame lowest floor is constructed above the flood level, and the roof, windows, and doors are reinstalled.

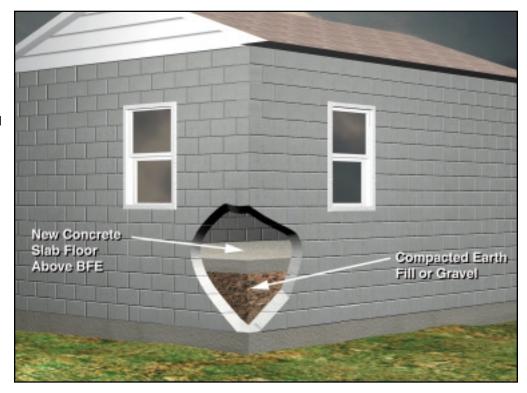
Figure 14
An alternative to building an elevated wood-frame floor is installing a new, elevated concrete slab floor on fill placed over the old slab.

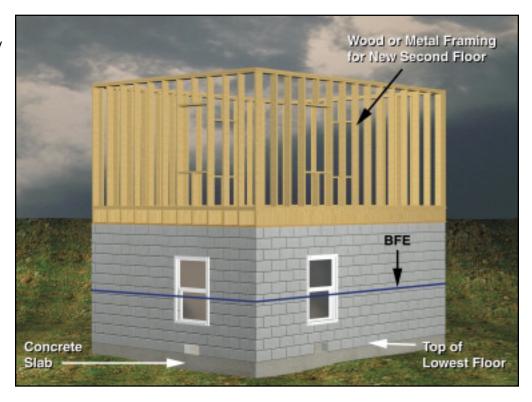
Figure 15
The new second-story floor and walls are built on top of the existing lower story.

As in Technique 1, the repairs begin with the temporary removal of the roof and roof framing (Figure 10). After the roof is removed, construction of the new second story begins. First, a new wood-frame floor is built on top of the existing lower-story walls. The second-story walls are framed with metal or wood study and set in place on the floor (Figure 15).

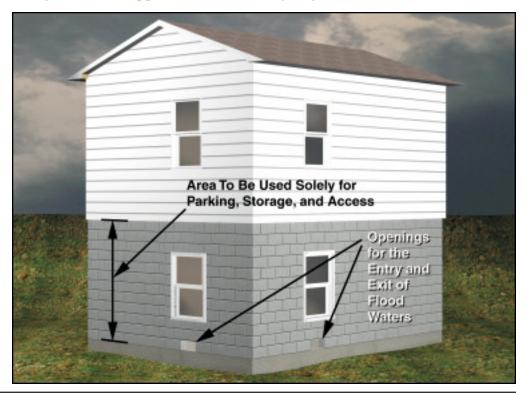
Figure 16
The new second-story walls are covered with siding or stucco.

Some homeowners prefer that the second story be constructed of masonry, but wood- or metal-framing is more common, primarily because it is lighter and less expensive. The roof is replaced, and blocks are removed from the walls to allow flood waters to enter and exit. Exterior sheathing is then added to the framed walls of the second story, the new windows are installed, and siding or stucco is applied to the sheathing (Figure 16).

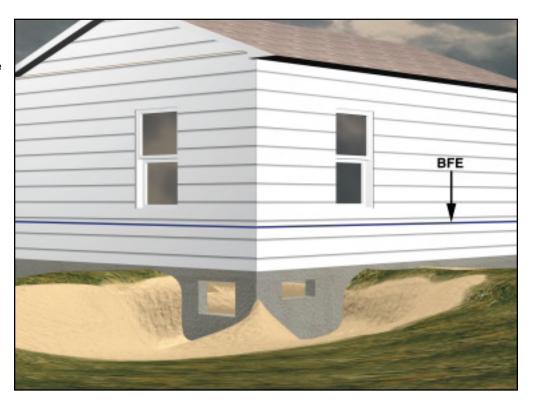
Figure 17
Trenches and tunnels under the slab provide access for the jacks and I-beams that will lift the house.

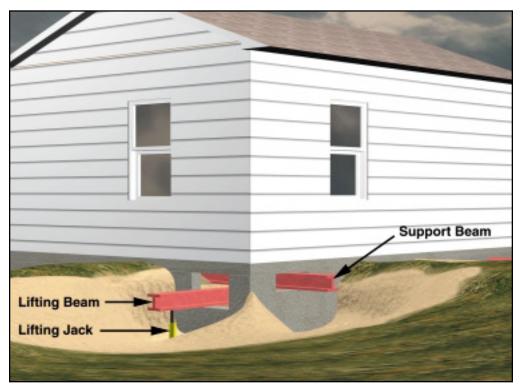
Figure 18
With I-beams and jacks in place, the house is ready to be lifted.

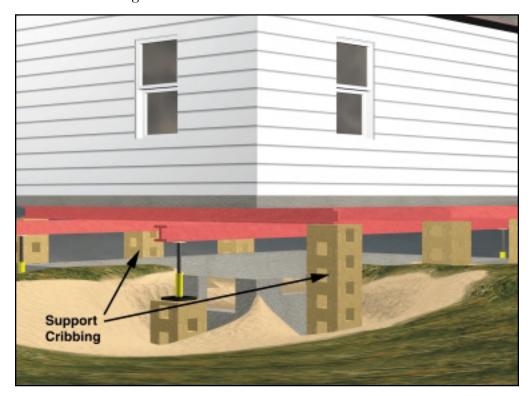
Figure 19
The house is temporarily supported on cribbing.

The house is then jacked up. When the jacks have extended as far as possible, the house must be supported temporarily while the jacks are raised. Both the house and the jacks are usually supported on "cribbing"—temporary piles of crisscrossed timbers (Figure 19). The jacks are then used to raise the house higher.

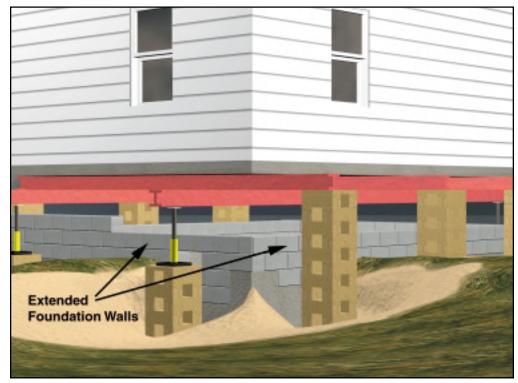
Figure 20 New, extended foundation walls are constructed with concrete blocks.

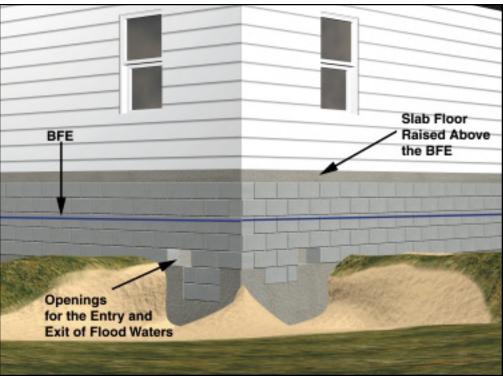
Figure 21
Elevated house and slab on new, extended foundation walls.

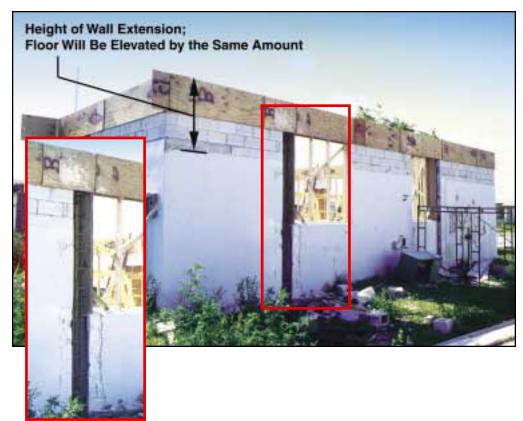
Another view of the extended walls. The vertical cuts in the walls next to the windows are for concrete tiedown columns that will be cast in place to further strengthen the extended walls against wind loads. The owner of this house was able to meet the elevation requirement by raising the floor only a few feet, as indicated by the amount that the walls have been extended.

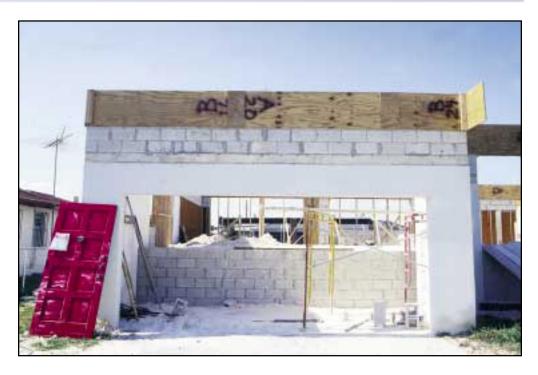
Figure 25

This view through the garage door reveals the different levels of the elevated slab floor, in the background, and the unelevated garage floor.

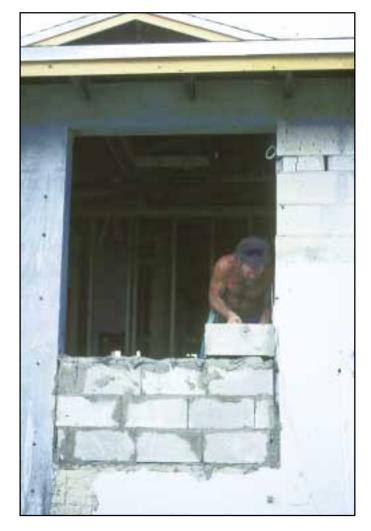
Figure 28
The bottoms of the original window openings are raised with concrete blocks.

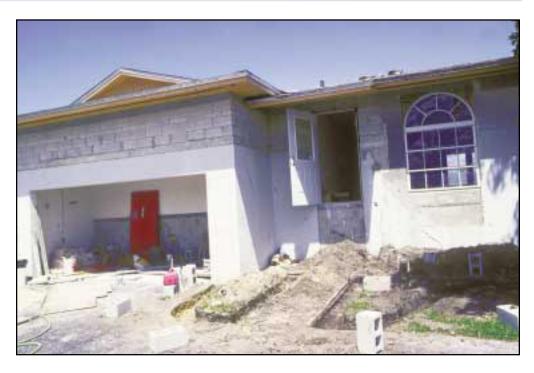
Figure 29
Windows and doors
are added. The height
of the raised front

are added. The height of the raised front door shows the amount of elevation.

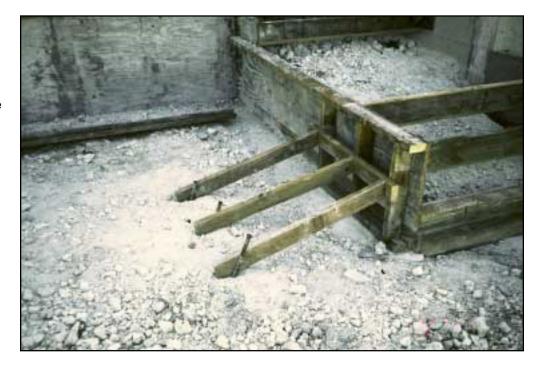
Figure 33
Wood framing for a
new concrete
staircase that will
provide access to the
elevated floor.

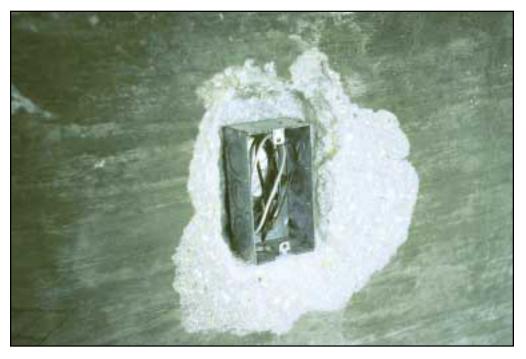
Figure 35
The electrical system is upgraded to meet current code requirements.

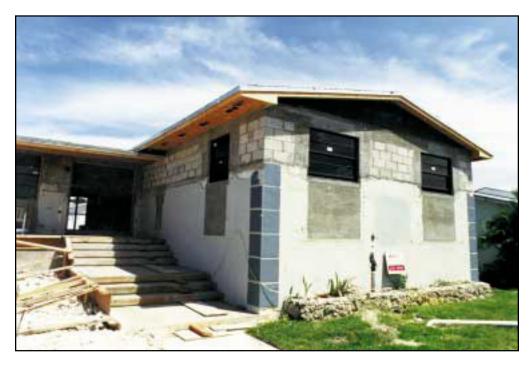
Figure 36 In this view from the front of the house, the amount of

elevation is shown by the rows of concrete block on the tops of the original walls and by the raised window openings.

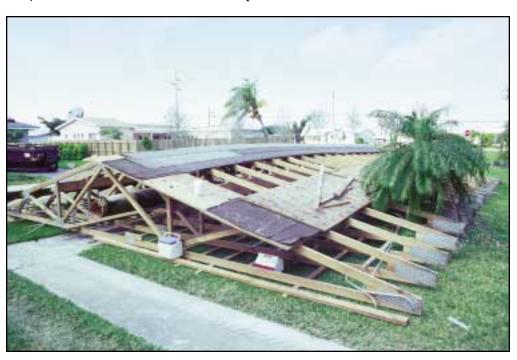
Figure 39
The roof of this house was removed as a single piece; the trusses were held together with bracing and portions of the original roof sheathing. This approach made it easier to reinstall the roof at the end of the project.

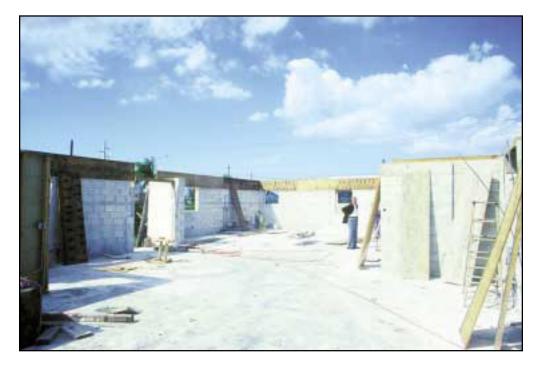
Figure 40

After the roof was removed and the storm-damaged interior gutted, the walls of the house were extended upward and a new bond beam added at the top.

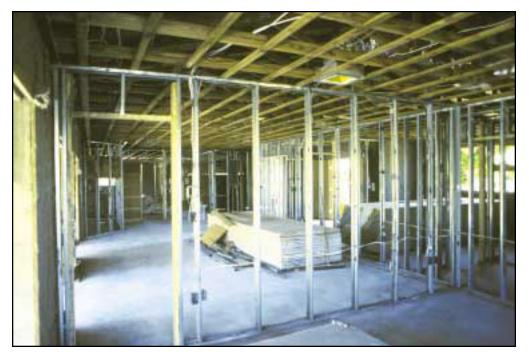
Figure 43
The owner of this house decided to use light-gauge metal framing for the new interior walls.

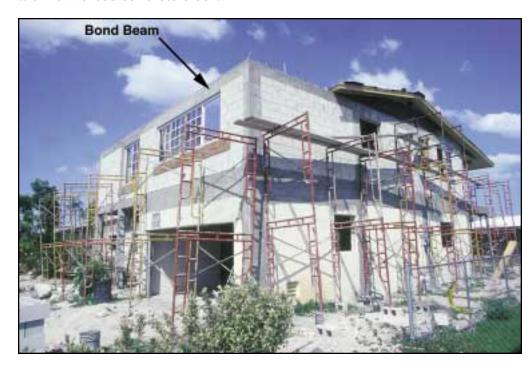
Figure 45
Concrete bond
beams similar to
those shown earlier
were used in this
house, but here they
were installed on the
tops of both the
original first-story
walls and the new
reinforced concrete
block second-story
walls.

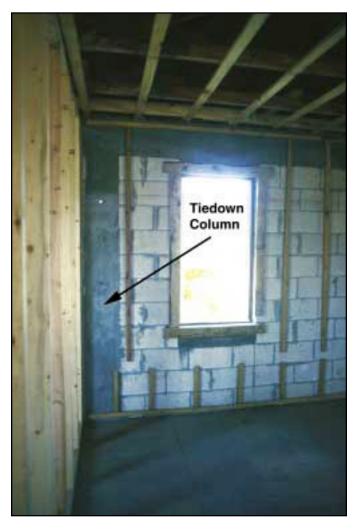
Figure 46
Concrete tiedown
columns, such as the
one to the left of the
window in this
photograph, were also
used in this house.

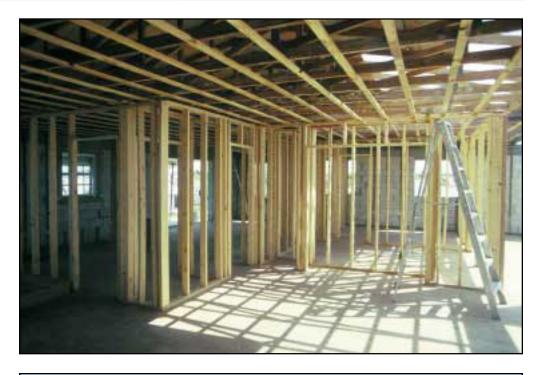
Figure 48
Wood 2 by 4 studs
were used to frame
the interior walls of
the second story.

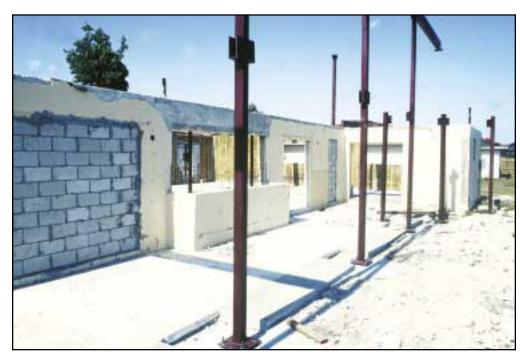
Figure 52

The existing first-story walls have been strengthened by the addition of concrete block. Metal columns and beams have been added to help support the new second story.

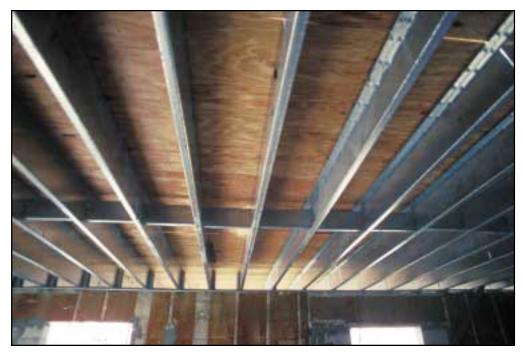
Figure 55
Metal framing also
supports the floor of
the new second story.

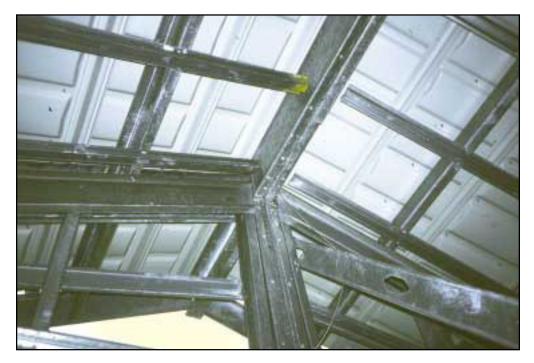
Figure 56

One advantage of metal framing is its relatively light weight. An additional advantage is that the screws used to attach metal-frame components provide strong connections.

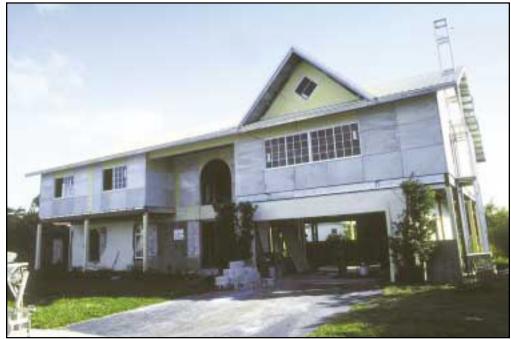
The new second story nears completion. The roof is made of formed metal panels.

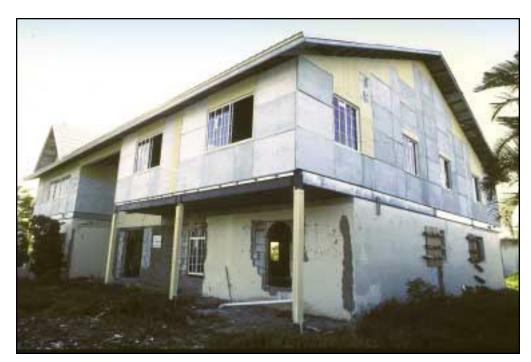
Figure 59

The exterior walls consist of prefabricated concrete panels. Innovative techniques such as those employed in this project are helping homeowners who need practical and economical methods of repairing and protecting their houses.

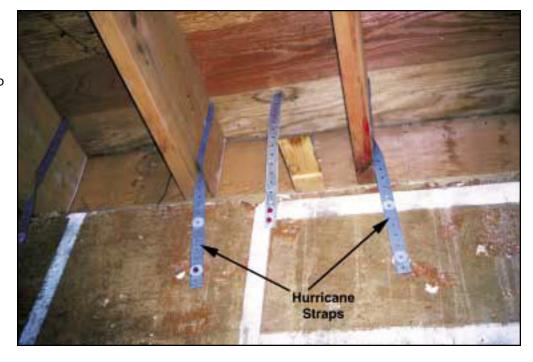
Figure 63
The new secondstory walls are securely connected to the original first-floor walls with galvanized metal hurricane straps.

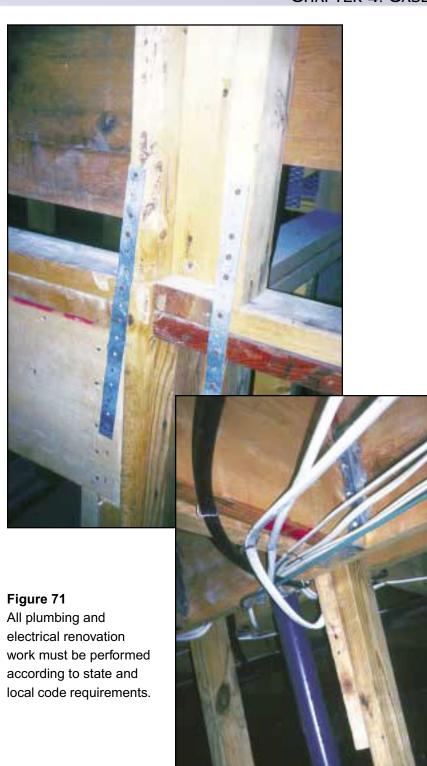
Figure 70
Metal hurricane straps are used to tie the structural members together and create a continuous load path from the roof to the foundation.

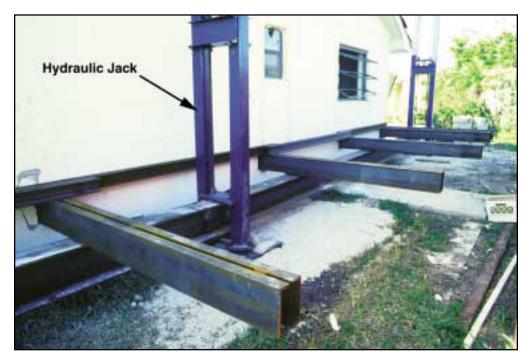
Figure 74

In this variation of Technique 3, steel beams are inserted through the walls of the house rather than under the slab. The beams span the length and width of the house and cross one another inside to create a grid. Outside the house, the beams rest on larger beams that will be raised with hydraulic jacks.

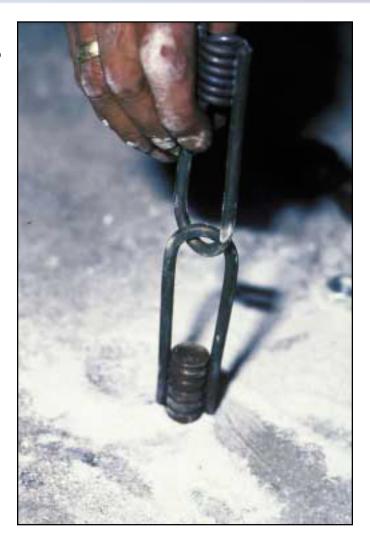
Figure 78 ... and use hangers to attach the anchors to the grid of steel beams.

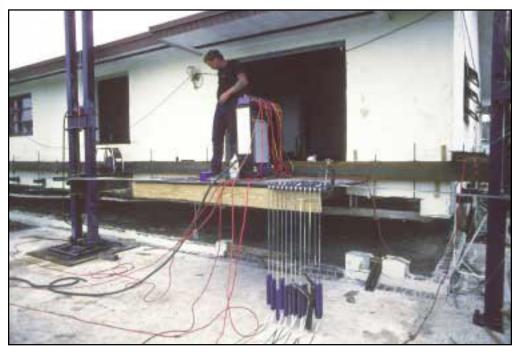
Figure 79
The anchors and
hangers connect the
slab securely to the
beams, enabling the
beams to raise the
slab along with the
rest of the house.

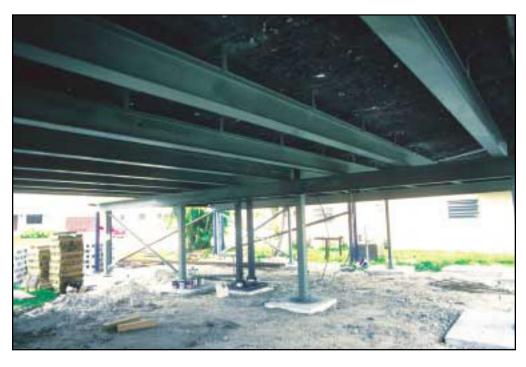
Figure 82
While the jacks and beams supported the house, new steel foundation members were installed below.
